linea 6012

VANDE MOORTELE
CLAY PAVERS • FACING BRICKS • SLIP

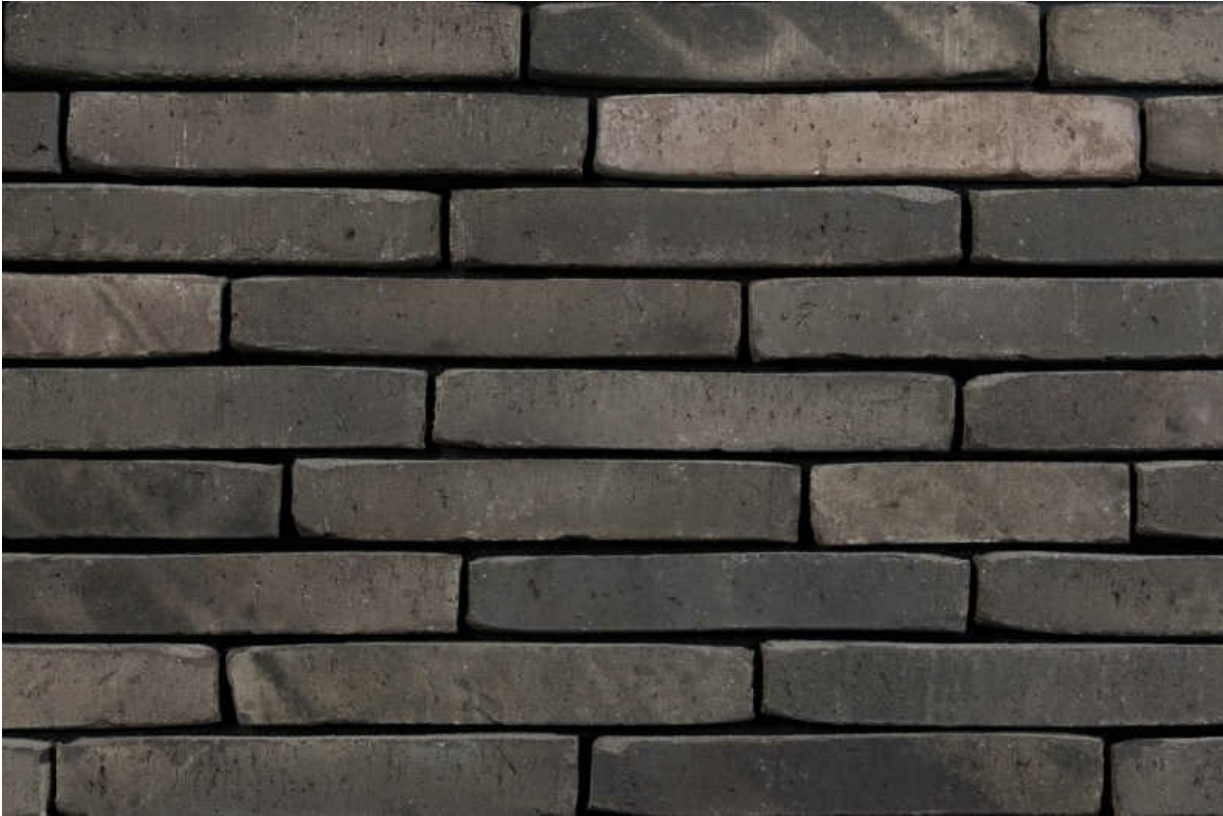
Productshot

The decorative brickwork (inside and/or outside face) is made with a solid unsanded moulded brick without grain with a very uneven structure. Due to the natural reduction with coal the bricks have a strong fired rough field fire aspect. Some visible sides of the brick also contain traces of coal and of the manual production method. The colour of the body is grey-green-brown to black-green with nuances.
